Manhole Inspection Summary

Manhole # S23AA1003MH

Insp Date: **1/29/07 1:32 PM**

Location Address: **1448 36TH ST**

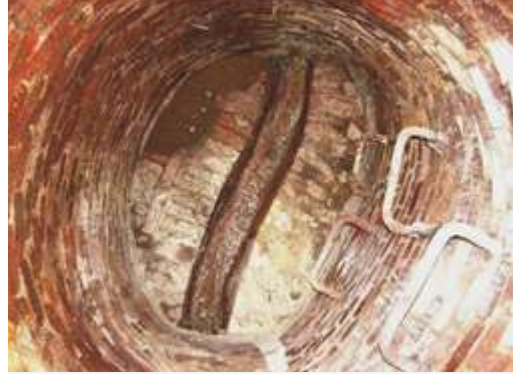
Top View

Corroded steps. Bench debris.

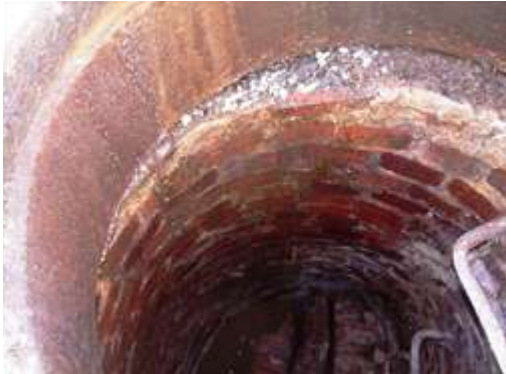
Defect

Condition: ☐ Sound ☐ Cracked ☒ **Leaks**

Condition: ☐ Sound ☐ Cracked ☐ Root Intrusion ☐ Loose Brick ☒ **Deteriorated**

Infiltration: ☐ None ☒ **Joint** ☐ Cracks ☒ **Mortar** ☐ Roots ☐ Wall

Frame leaks. Frame offset. Adjustment deterioration and infiltration. Corbel and Barrel infiltration.

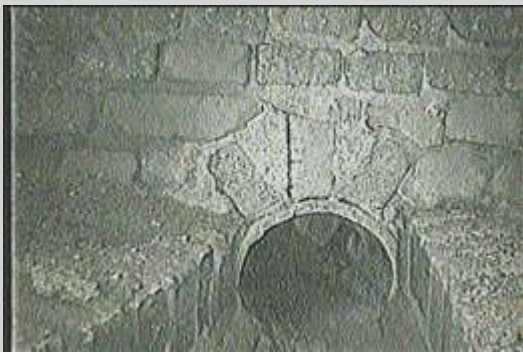
Pipe Out @ 12 O'Clock

Barrel deterioration and infiltration. Channel deterioration.

Infiltration: **None** Pipe Seal Cond: **Cracked**

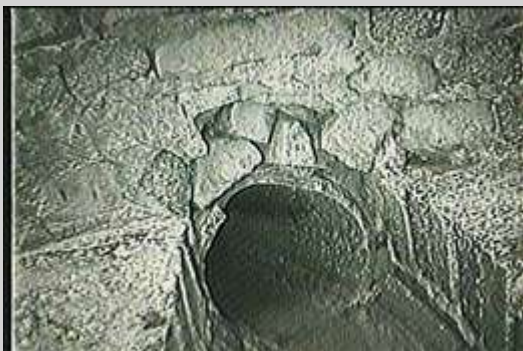
Pipe In @ 6 O'Clock

Barrel deterioration, loose brick and infiltration. Channel deterioration.

Infiltration: **Evidence** Pipe Seal Cond: **Broken**
